ROSPA report 2024 -

Works officers action Plan.

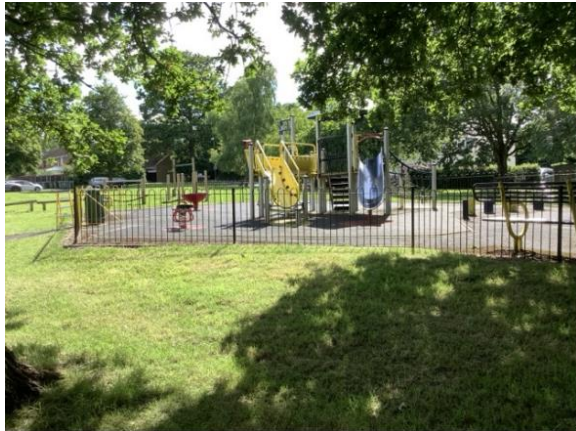
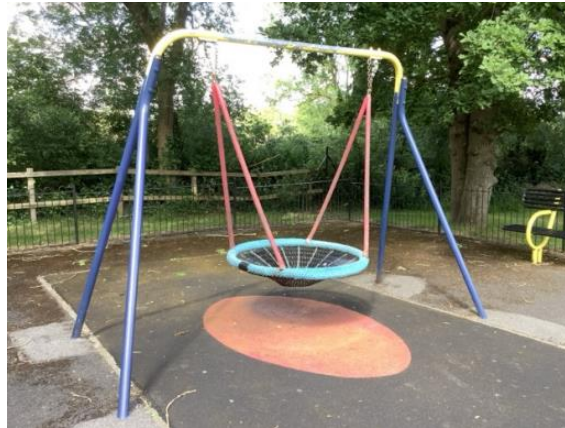
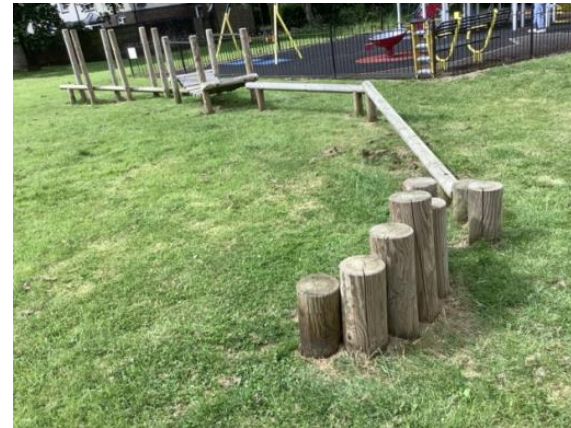
CHESSBROOK GREEN

WORK REQUIRED	RISK LEVEL	DATE COMPLETED
Swing basket, re-glue & fill gaps & joints as necessary.	Medium	
Balance trail- logs loose in ground, to be reset.	Medium	
Agility ladder-Consult with manufacturer for guidance re suitable maintenance	Medium	
NOTES-

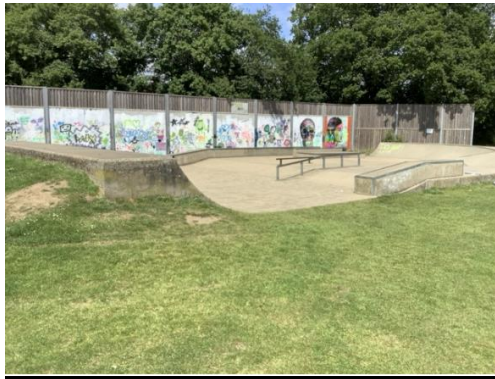
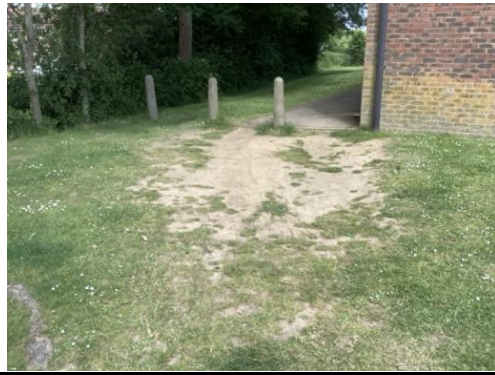
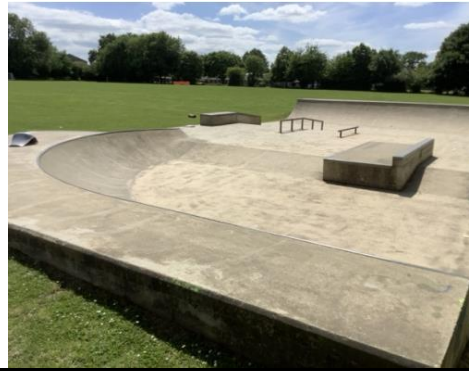
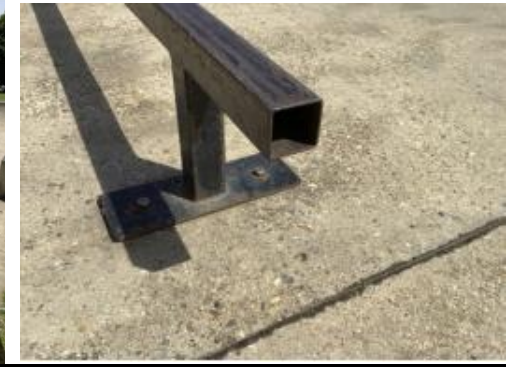
HENFIELD SKATE PARK

WORK REQUIRED	RISK LEVEL	DATE COMPLETED
General surface is uneven, shallow holes now forming-Make good	Medium	
Access-ground erosion present on grass path from Youth club to skate park	Medium	
Free form street course, replace missing cap from end of rail	High	
Basketball post-item is bent	Medium	
Surface area is cracking- monitor & repair as required	Medium	
Gap between plates exceeds 5mm- repair	Medium	
NOTES-

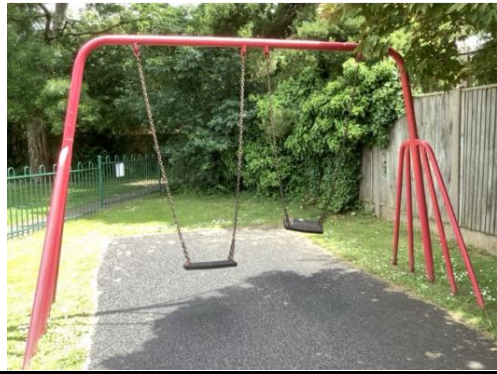
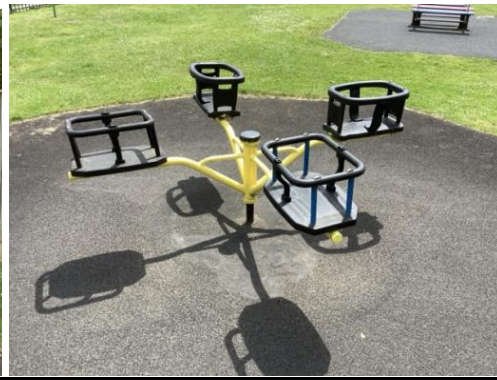
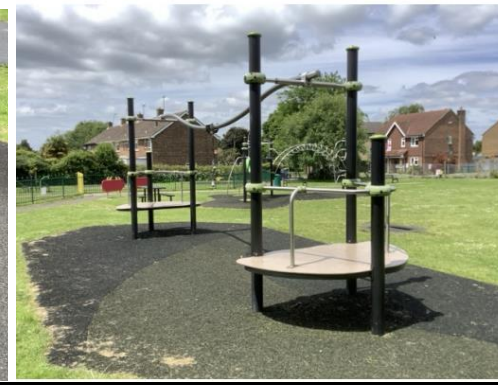
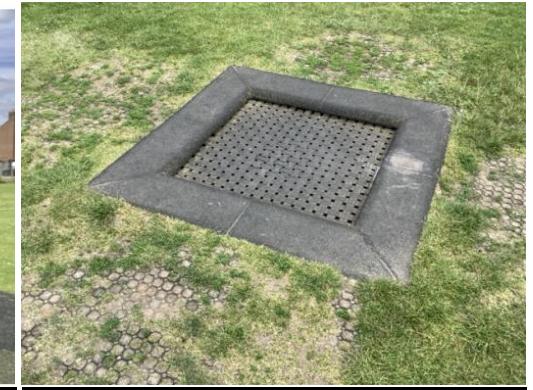
KINGSFIELD PLAY AREA

WORK REQUIRED	RISK LEVEL	DATE COMPLETED
Swing, junior, seat bolt loose, vertical support – Check for cracks, consult Wicksteed for advice, replace parts and repair.	Medium	
Trampoline, trip points on surface- Make level	Medium	
Carousel whirl, projecting bolt head-Cut off & file or use correct length bolt	Medium	
Runway, wear in the bushes-remove shackle bolt & check bush & shackle pin wear, replace if necessary	Medium	
NOTES-

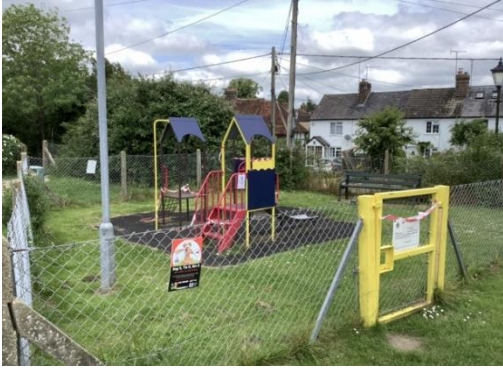
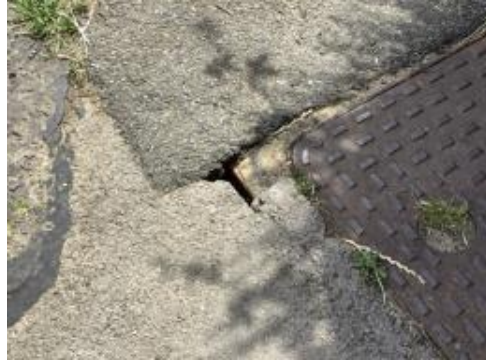
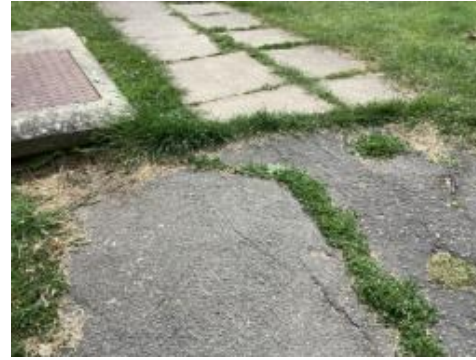
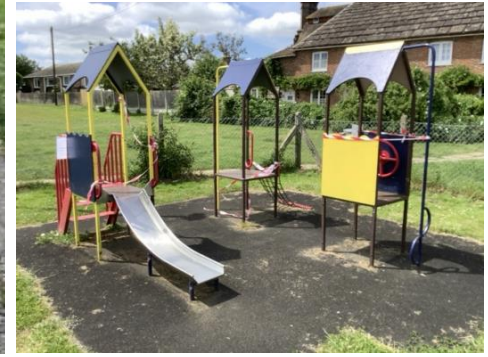
ROTHERY FIELD

WORK REQUIRED	RISK LEVEL	DATE COMPLETED
Pathways, trip points on surface- remove trip points	Medium	
Paving pathway has holes in it- repair	Medium	
Trip point near inspection cover & gate- remove trip points	Medium	
NOTES-

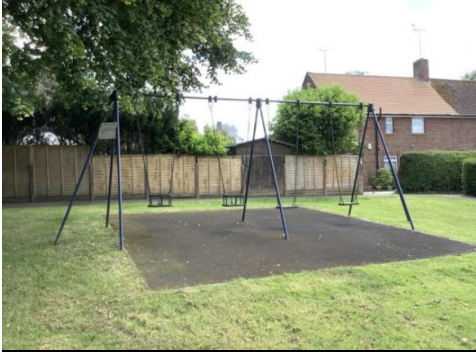
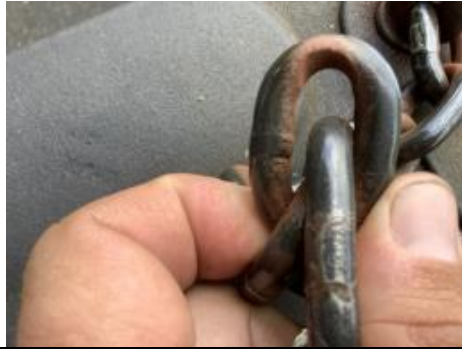
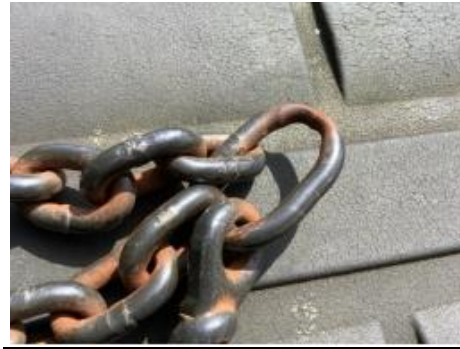
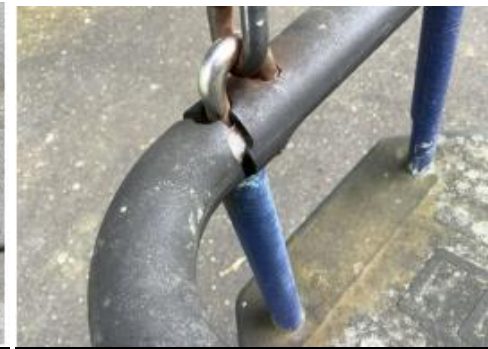
WANTLEY HILL ESTATE

WORK REQUIRED	RISK LEVEL	DATE COMPLETED
Trees, overhanging branches-regular arboricultural surveys are completed, remove obstructions & overhanging branches	Medium	
Swing seat damage-not immediate replacement required so monitor, replace when hard material exposed	Medium	
Swing, some chain wear- Monitor for further deterioration and replace before 40% wear.	Medium	
Swing shackles, bushes and associated connections need servicing -repair	Medium	
NOTES-
