# Safety Inspection Report

Annual Inspection

## Wantley Hill Estate

19 June 2024

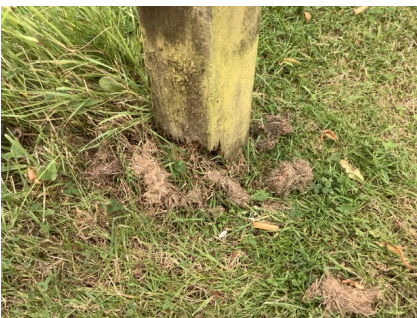
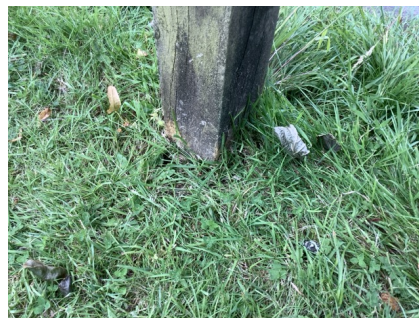
Timber is decayed.

Some post decayed and loose in ground,.

Check on a routine basis., Replace affected parts.

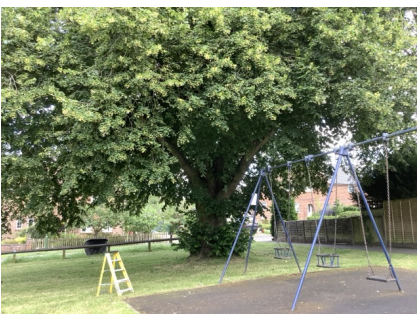
Overhanging tree branches are present.

Read the notes for further action.

Ensure regular arboricultural surveys are completed on the large trees in and next to the playing space.

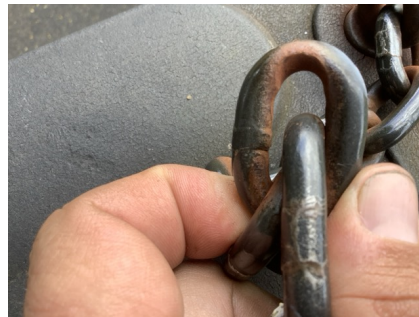
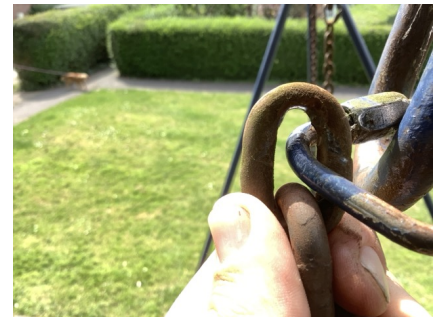
Some chain wear.

Junior seat chains now reaching wear limits.

Monitor for further deterioration and replace before 40% wear.

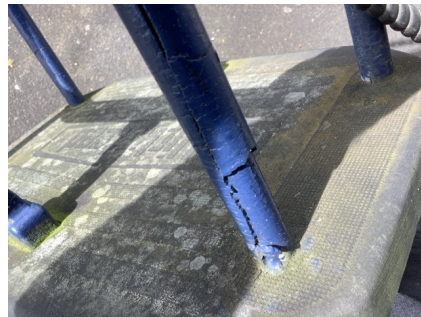
The swing seat has been damaged, but does not require immediate replacement.

both cradles.

Monitor and replace when hard material is exposed.

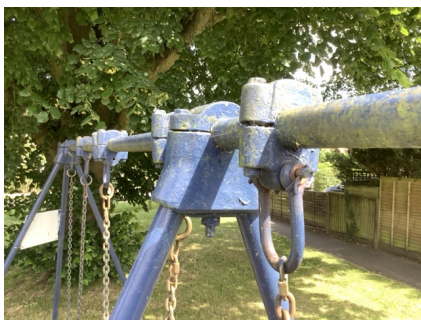
We are unable to gauge the structural integrity of this unit.

We advise an internal inspection of all parts or replacement.

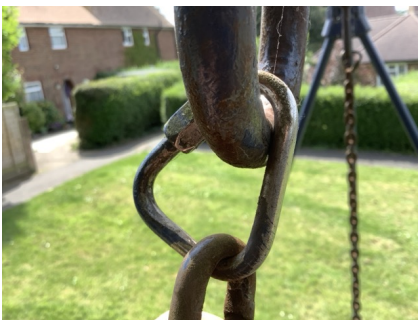
Additional comments are noted below.

Replacement quick links doesn't look heavy enough to be able to cope with the intended use.

Repair.

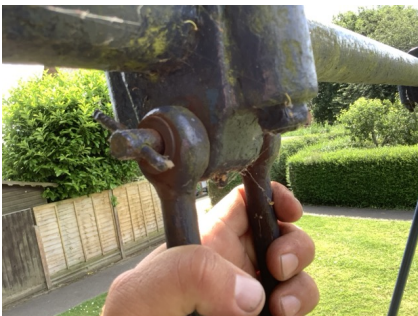
Swing shackles, bushes and associated connections need servicing.

Repair.

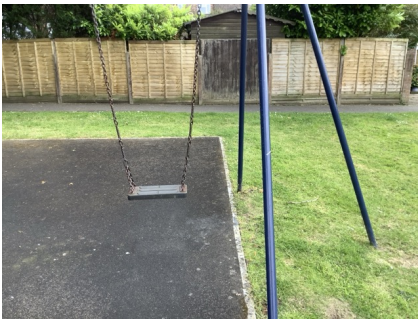
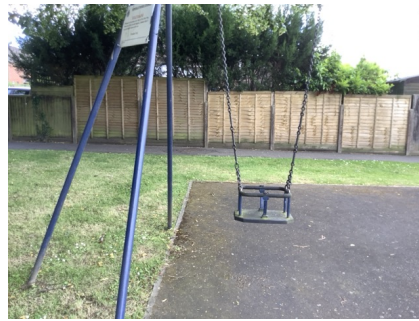
The distance between the seat side and the support is insufficient.

No reasonably practicable action is identified.
